**Flood Control Project Maintenance
Levee Inspections**

Maintenance Issue Types Only, Levee Inspection Report By Mile - Spring 2017

Reclamation District No. 0827 Elkhorn

Waterway	Bank	Unit Miles	Inspection Start/End	Inspector
Unit No. 01 Sacramento River	Right	1.34	04/12/2017 04/12/2017	Zach Jojola

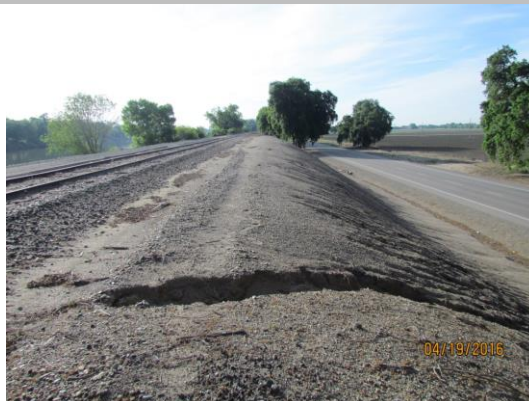
Photo 1 of 2 : SP_2017_RD0827_187_13_20170320_00005.jpg

LM Start	0.51	Rating **	M	Issue No.	13
LM End	0.51	Issue Type +	Ma	Location *	LS
Category	Earthen Levee			GPS Latitude/Longitude	
				Start	End
Item	Erosion / Bank Caving			38.669929 °	38.669929 °
				-121.623776 °	-121.623776 °
DWR ID	DWR_RD0827_01_s_2016_13				
Comment Code					
E2 : Schedule repair of erosion site prior to the next inspection.					
Inspector Comment					
Rills caused by rain.

View of the erosion on the landward side of the levee looking downstream. Spring 2016.

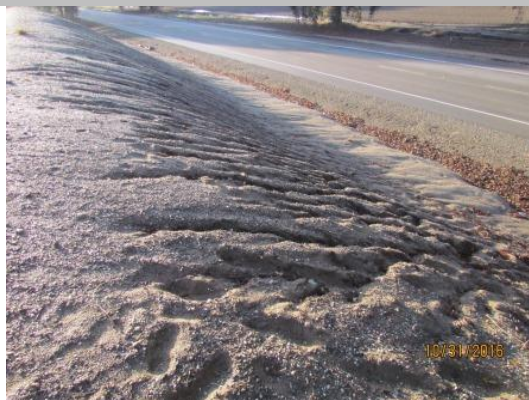
Photo 2 of 2 : SP_2017_RD0827_187_13_20170320_00006.jpg

Updated view of runoff erosion site. LS slope. Fall 2016.

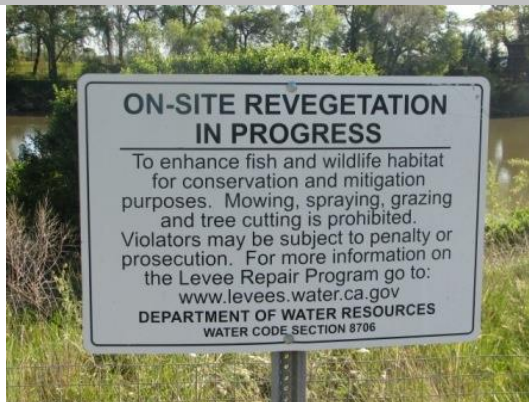
Photo 1 of 2 : SP_2017_RD0827_187_22_20170320_00007.jpg

LM Start	0.61	Rating **	A/W	Issue No.	22
LM End	0.92	Issue Type +	Ma	Location *	WS
Category	Earthen Levee			GPS Latitude/Longitude	
				Start	End
Item	Vegetation			38.668873 °	38.665750 °
				-121.622513 °	-121.618523 °
DWR ID	DWR_RD0827_01_s_2012_22				
Comment Code					
V8 : Environmental Requirements.					
Inspector Comment

Revegetation site spring 2012.

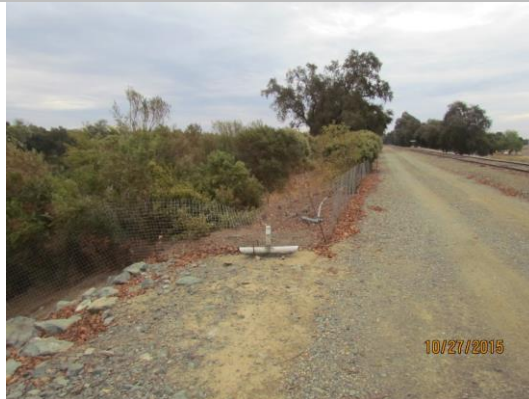
Photo 2 of 2 : SP_2017_RD0827_187_22_20170320_00008.jpg

View of the revegetation site on the waterward side of the levee looking downstream. Fall 2015.

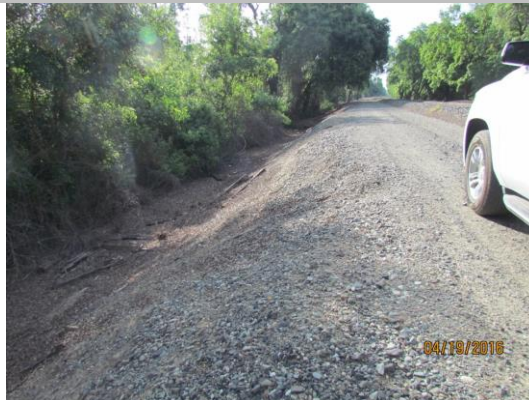
Photo 1 of 1 : SP_2017_RD0827_187_213_20170320_00011.jpg

LM Start	0.96	Rating **	M	Issue No.	213
LM End	0.96	Issue Type +	Ma	Location *	WS
Category	Earthen Levee			GPS Latitude/Longitude	
				Start	End
Item	Slope Stability			38.665307 °	38.665307 °
				-121.617982 °	-121.617982 °
DWR ID	DWR_RD0827_01_s_2015_213				
Comment Code					
S1 : Repair slope instability.					
Inspector Comment

View of the slope instability on the waterward side of the levee looking downstream. Spring 2016.

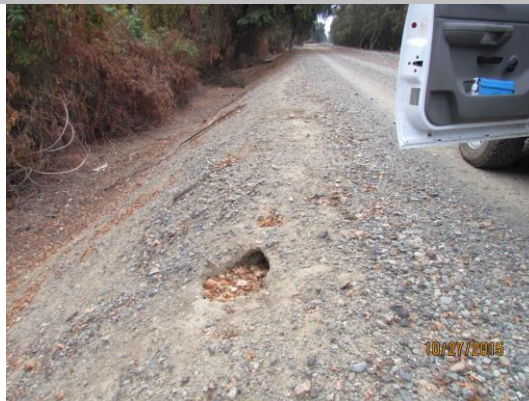
Photo 1 of 1 : SP_2017_RD0827_187_8_20170320_00002.jpg

LM Start	0.97	Rating **	M	Issue No.	8
LM End	0.97	Issue Type +	Ma	Location *	WS
Category	Earthen Levee			GPS Latitude/Longitude	
				Start	End
Item	Animal Control			38.665213 °	38.665213 °
				-121.617886 °	-121.617886 °
DWR ID	DWR_RD0827_01_f_2015_8				
Comment Code					
A3 : No rodents visible, but rodent burrows visible; need to backfill and compact or grout burrows.					
Inspector Comment

View of the rodent hole on the waterward side of the levee looking downstream. Fall 2015.

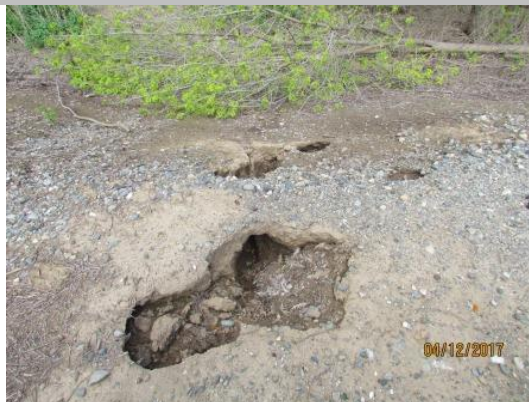
Photo 1 of 3 : SP_2017_RD0827_187_3_20170413_00015.jpg

LM Start	1.12	Rating **	M	Issue No.	3
LM End	1.12	Issue Type +	Ma	Location *	WS
Category	Earthen Levee			GPS Latitude/Longitude	
				Start	End
Item	Erosion / Bank Caving			38.663542 °	38.663542 °
				-121.616056 °	-121.616056 °
DWR ID	DWR_RD0827_01_f_2016_3				
Comment Code					
E2 : Schedule repair of erosion site prior to the next inspection.					
Inspector Comment					
Erosion on the crown and levee slope that has become worse due to runoff.

Updated view of erosion on waterside levee slope. Spring 2017.

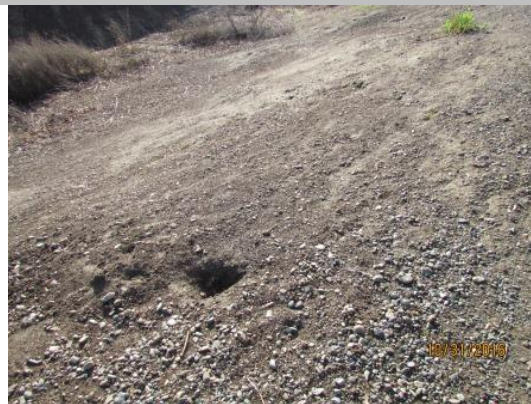
Photo 1 of 1 : SP_2017_RD0827_188_7_20170320_00004.jpg

LM Start	0.11	Rating **	M	Issue No.	7
LM End	0.11	Issue Type +	Ma	Location *	LS
Category	Earthen Levee			GPS Latitude/Longitude	
				Start	End
Item	Animal Control			38.675326 °	38.675326 °
				-121.643042 °	-121.643042 °
DWR ID	DWR_RD0827_02_f_2016_7				
Comment Code					
A3 : No rodents visible, but rodent burrows visible; need to backfill and compact or grout burrows.					
Inspector Comment

Rodent holes on LS levee slope. Fall 2016.

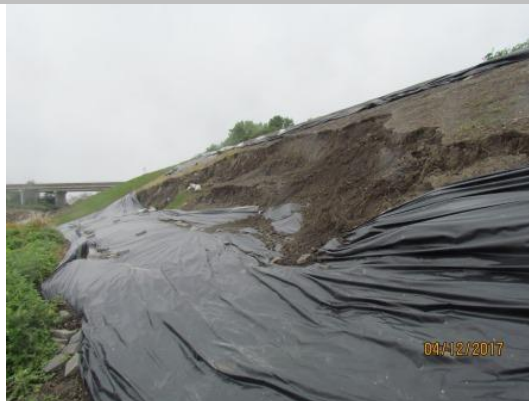
Photo 1 of 1 : SP_2017_RD0827_188_11_20170413_00024.jpg

LM Start	0.16	Rating **	U	Issue No.	11
LM End	0.16	Issue Type +	Ma	Location *	LS
Category	Earthen Levee			GPS Latitude/Longitude	
				Start	End
Item	Erosion / Bank Caving			38.674523 °	38.674523 °
				-121.642767 °	-121.642767 °
DWR ID	DWR_RD0827_02_s_2017_11				
Comment Code					
E2 : Schedule repair of erosion site prior to the next inspection.					
Inspector Comment					
100' section of sloughing on landside levee slope.

View of sloughing on landside levee slope. LMA placed visqueen to prevent further erosion, which has since fallen down. Spring 2017.

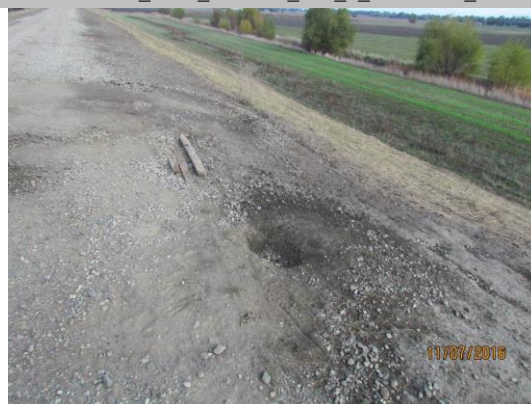
Photo 1 of 1 : SP_2017_RD0827_188_9_20170320_00006.jpg

LM Start	2.01	Rating **	M	Issue No.	9
LM End	2.01	Issue Type +	Ma	Location *	CR
Category	Earthen Levee		GPS Latitude/Longitude		
			Start	End	
Item	Crown Surface / Depressions / Rutting		38.651270 °	38.651270 °	
			-121.626661 °	-121.626661 °	
DWR ID	DWR_RD0827_02_f_2016_9				
Comment Code					
C2 : Repair depressions or ruts in the crown or slope.					
Inspector Comment

View of crown depression site. Fall 2016.

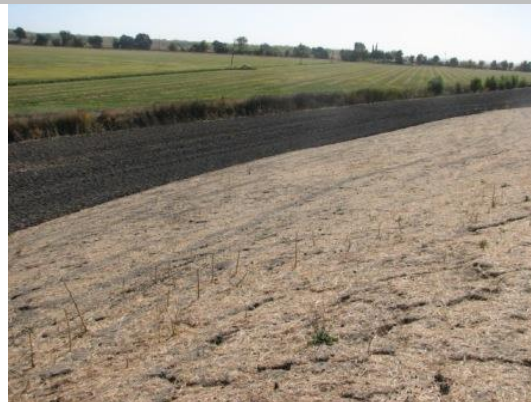
Photo 1 of 1 : SP_2017_RD0827_188_24_20170320_00010.jpg

LM Start	2.29	Rating **	A/W	Issue No.	24
LM End	2.29	Issue Type +	Ma	Location *	LS
Category	Earthen Levee			GPS Latitude/Longitude	
				Start	End
Item	Slope Stability			38.647703 °	38.647703 °
				-121.624450 °	-121.624450 °
DWR ID	DWR_RD0827_02_s_2012_24				
Comment Code					
S1 : Repair slope instability.					
Inspector Comment					
Cracking along the levee slope is less than 200 feet in length. Monitor the slope for changes in cracking.

A bulge in the levee slope. Photo fall 2012.

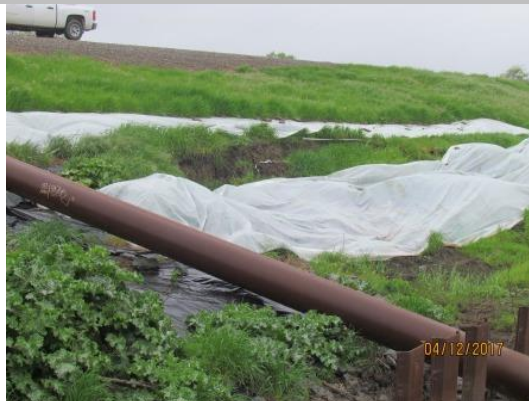
Photo 1 of 4 : SP_2017_RD0827_188_14_20170413_00025.jpg

LM Start	2.72	Rating **	M	Issue No.	14
LM End	2.74	Issue Type +	Ma	Location *	LS
Category	Earthen Levee			GPS Latitude/Longitude	
				Start	End
Item	Erosion / Bank Caving			38.642088 °	38.641817 °
				-121.620972 °	-121.620802 °
DWR ID	DWR_RD0827_02_s_2017_14				
Comment Code					
E2 : Schedule repair of erosion site prior to the next inspection.					
Inspector Comment					
Erosion on landside levee slope near LMA pump. Visqueen and bricks placed to prevent further erosion.

View of erosion and visqueen on landside levee slope. Spring 2017.

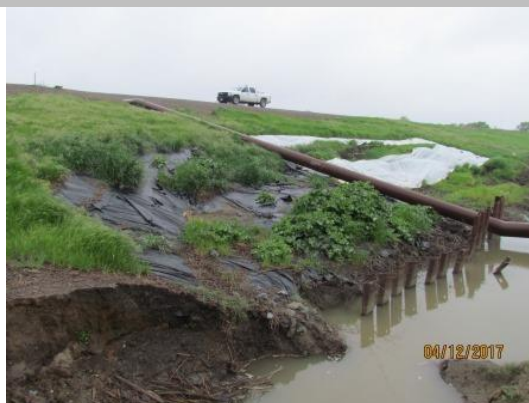
Photo 2 of 4 : SP_2017_RD0827_188_14_20170413_00026.jpg

Additional view of erosion on landside levee slope. Spring 2017.

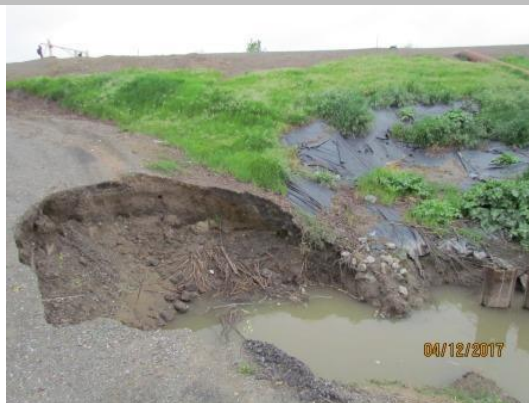
Photo 3 of 4 : SP_2017_RD0827_188_14_20170413_00028.jpg

Another view of erosion on landside levee slope. Spring 2017.

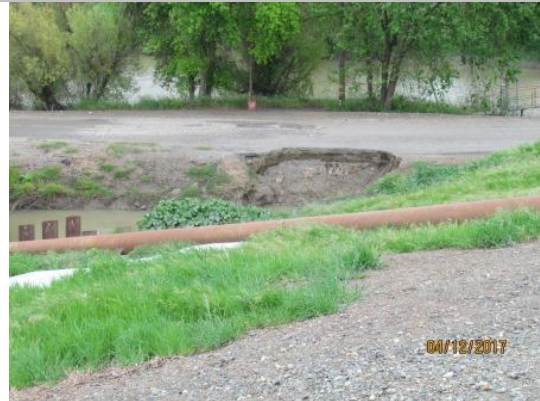
Photo 4 of 4 : SP_2017_RD0827_188_14_20170413_00027.jpg

LM Start	2.72	Rating **	M	Issue No.	14 (cont)
LM End	2.74	Issue Type +	Ma	Location *	LS
Category	Earthen Levee			GPS Latitude/Longitude	
				Start	End
Item	Erosion / Bank Caving			38.642088 °	38.641817 °
				-121.620972 °	-121.620802 °
DWR ID	DWR_RD0827_02_s_2017_14				
Comment Code					
E2 : Schedule repair of erosion site prior to the next inspection.					
Inspector Comment					
Erosion on landside levee slope near LMA pump. Visqueen and bricks placed to prevent further erosion.

Looking down levee slope. Spring 2017.

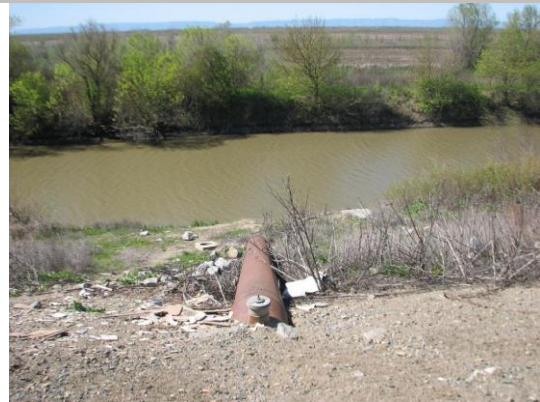
Photo 1 of 3 : UCIP_SP_2017_33032_59778.jpg

Comment Code					
Inspector Comment					
FS_ID:33032 DS_ID:21169 EP_NO: 5611 Repair Type: Non-Urgent Crossing Status: Found UCIP Comments: Crossing appears to have been removed and replaced under maintenance back in 2008. No permit has been found--need to contact owner to obtain additional information about replacement. FIELD_STRUCT_DESC: [RD No. 827 Pumping Plant] 22-inch (not 24-inch as mentioned in desk study) steel drainpipe through the levee, 8.0 feet below the crown. CM cutoff wall around pipe at center of levee. Siphon breaker on waterward slope. Flap gate on waterward end. Pipe is exposed along waterward slope. (USACE-1955). This entry matches the Drainage or Irrigation Structure referenced in O&M manual (Station 3+75). Portion of pipe was removed and replaced, from landward side to waterward shoulder, under Permit No. 5611 (1968). FS Date: 3/18/2014

Pipe exposed on waterward side.

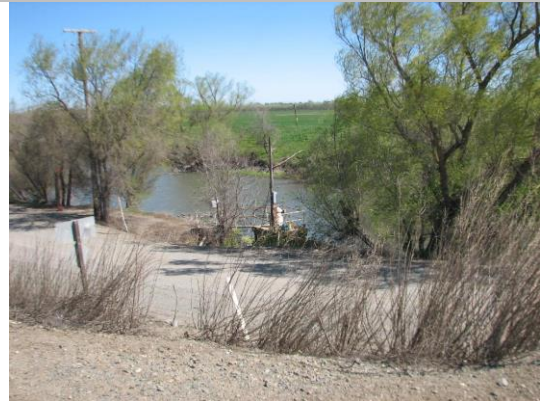
Photo 2 of 3 : UCIP_SP_2017_33032_59777.jpg

Pump station located on landward side.

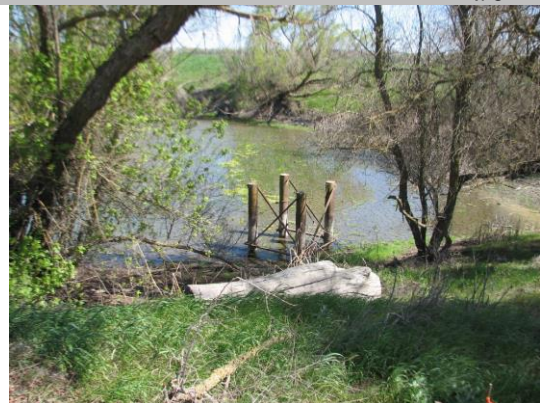
Photo 3 of 3 : UCIP_SP_2017_33032_59776.jpg

Remininse piles located on landward side.
